FIFTH FIVE-YEAR REVIEW REPORT FOR UNITED CHROME PRODUCTS, INC. SUPERFUND SITE BENTON COUNTY, OREGON

APRIL 2017

U.S. Environmental Protection Agency Region 10 Seattle, Washington

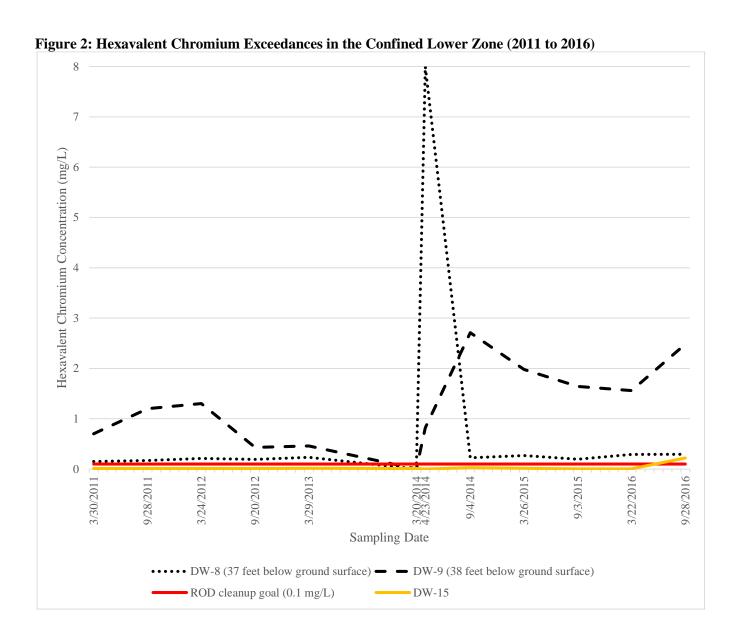
Trends for wells with cleanup goal exceedances in the last five years are graphed below in Figures 2 and 3; well locations are shown in Figure 4. All monitoring data for the last five years for hexavalent and total chromium in the confined lower zone is located in Appendix F. In DW-8 and DW-9, it appears that chromium is primarily in the hexavalent form, based on review of the total chromium data in Appendix F. Hexavalent and total chromium in DW-8 and DW-9 have consistently exceeded the cleanup goal (Figures 2 and 3). The unconfined upper zone appears to be continually contaminating the confined lower zone. Results show a general increase in both wells, with a large spike for DW-8 in April 2014 that has since decreased. The August 2014 project update memo stated that the cause of the spike was unclear. It may be due to the nearly-one-month shutdown of the pumping well or a

The concentrations of hexavalent chromium detected in downgradient wells DW-15 and DW-2 are below the cleanup goal, with the exception of one large spike at DW-15 during the September 2016 sampling event. This was the highest concentration measured at DW-15 since 2004. It is unknown whether the elevated concentration is due to limited migration of the dissolved phase plume or an anomaly. Evaluation of total chromium concentrations from 2014 to 2016, show that downgradient well DW-15 has fluctuated above the MCL and downgradient well DW-2 has fluctuated around the MCL (Figure 3). Wells DW-12 and DW-13, located downgradient of DW-15 and DW-2, have not exceeded the MCL. There are no monitoring wells located downgradient of wells DW-12 and DW-13. As contamination migrates from the source area (DW-8 and DW-9), it appears that trivalent chromium becomes the dominant form of chromium in the groundwater (DW-2 and DW-15). Based on these results, it is important to continue monitoring total chromium concentrations to ensure all MCL exceedances are identified and to consider monitoring groundwater downgradient of DW-2 and DW-15 due to the fluctuations in concentrations above and around the MCL in these wells. In addition, the last FYR recommended clarifying the groundwater point of compliance, because the point of compliance identified in the ROD (the plant site boundary) was not consistent with EPA's current groundwater remedial strategy; the point of compliance clarification has not been addressed.

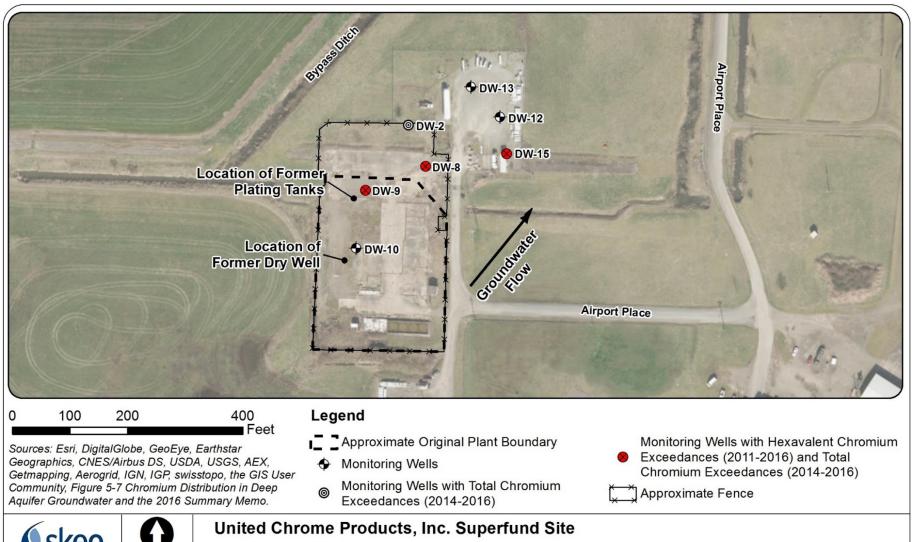
Figure 4: Detailed Site Map

In 2016, oil was found in well DW-12. It appears to have been caused by a trailer stationed on the northeast portion of the Site that was reportedly dripping a black liquid.
